REPORT AND PRELIMINARY RESULTS OF R/V POSEIDON CRUISE POS472

NORGEOTECH

**GEOTECHNICAL IN SITU INVESTIGATION OF SLOPE STABILITY IN
NORWAY**

**TRONDHEIM (NORWAY) – TROMSØ (NORWAY)
27.07.2014 – 12.08.2014**

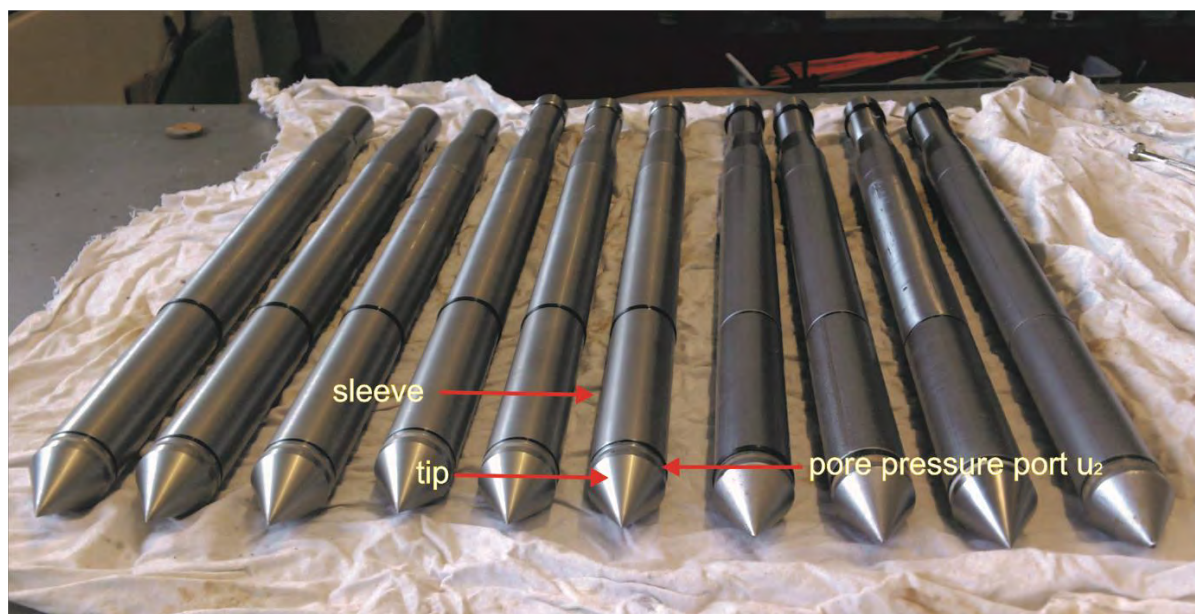
Figure 9 Digital pressure-compensated compression CPTu cones, as installed in the GOST system.

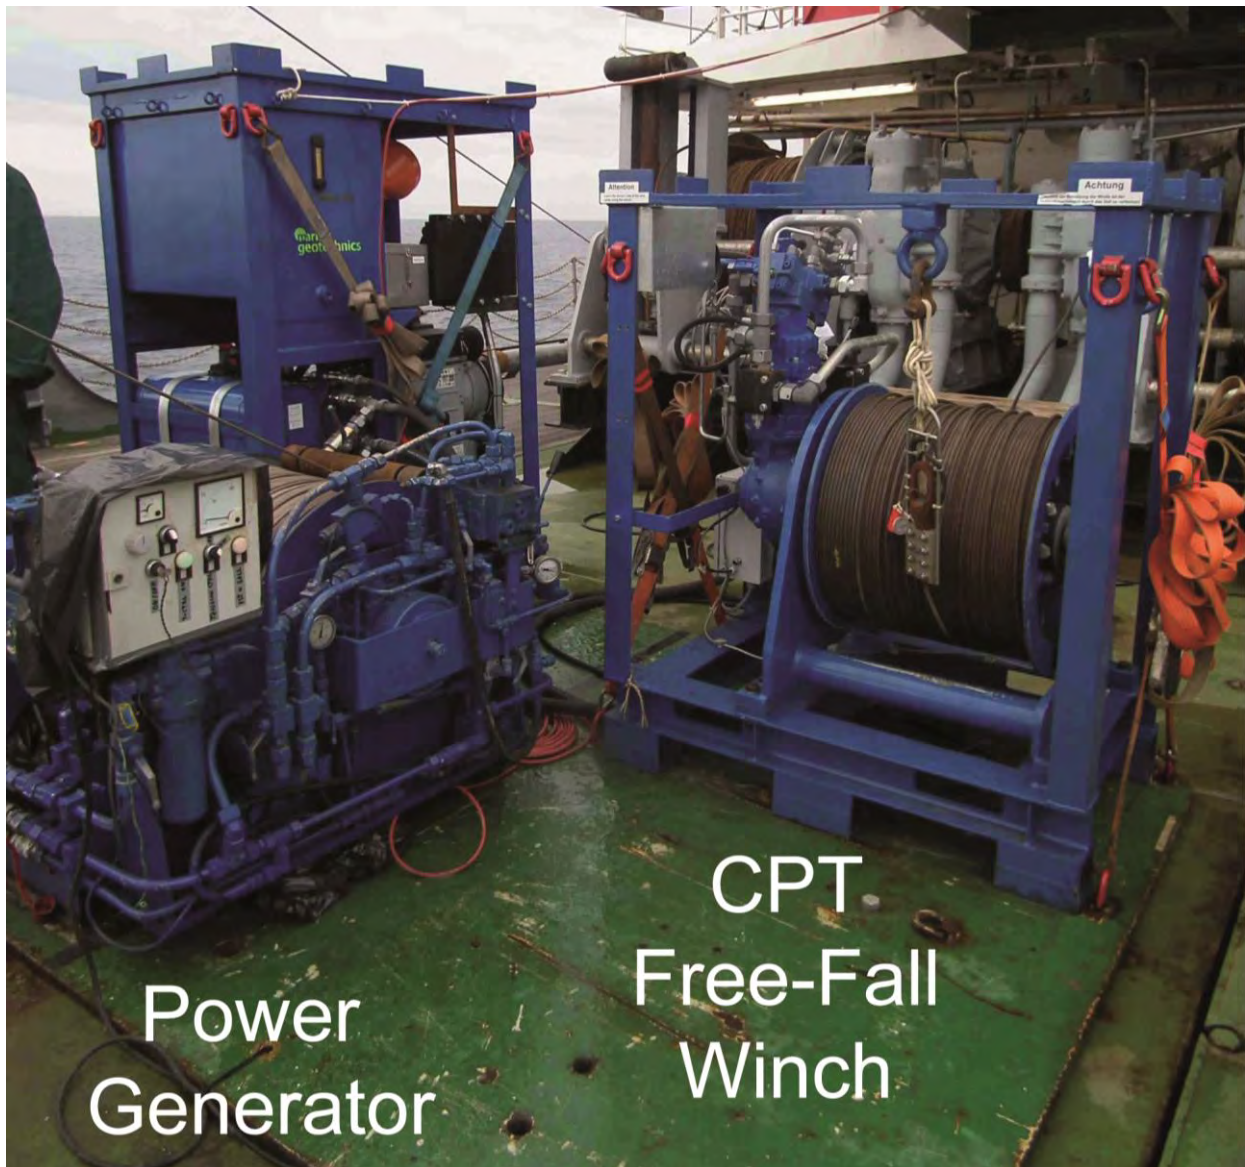
Figure 12 New MARUM FF-CPTu-Winch 200 m (left) and entire assembly together with hydraulic aggregate (right).

The winch as well as the aggregate is designed with a footprint of a standard Euro-palette, and the winch itself can be put either next to the aggregate, or on top of it (see Figure 12). The frame is equipped with leashing points, where the winch was fixed on the working deck of RV POSEIDON. Electrical power was provided by the aggregate of the GOST system.

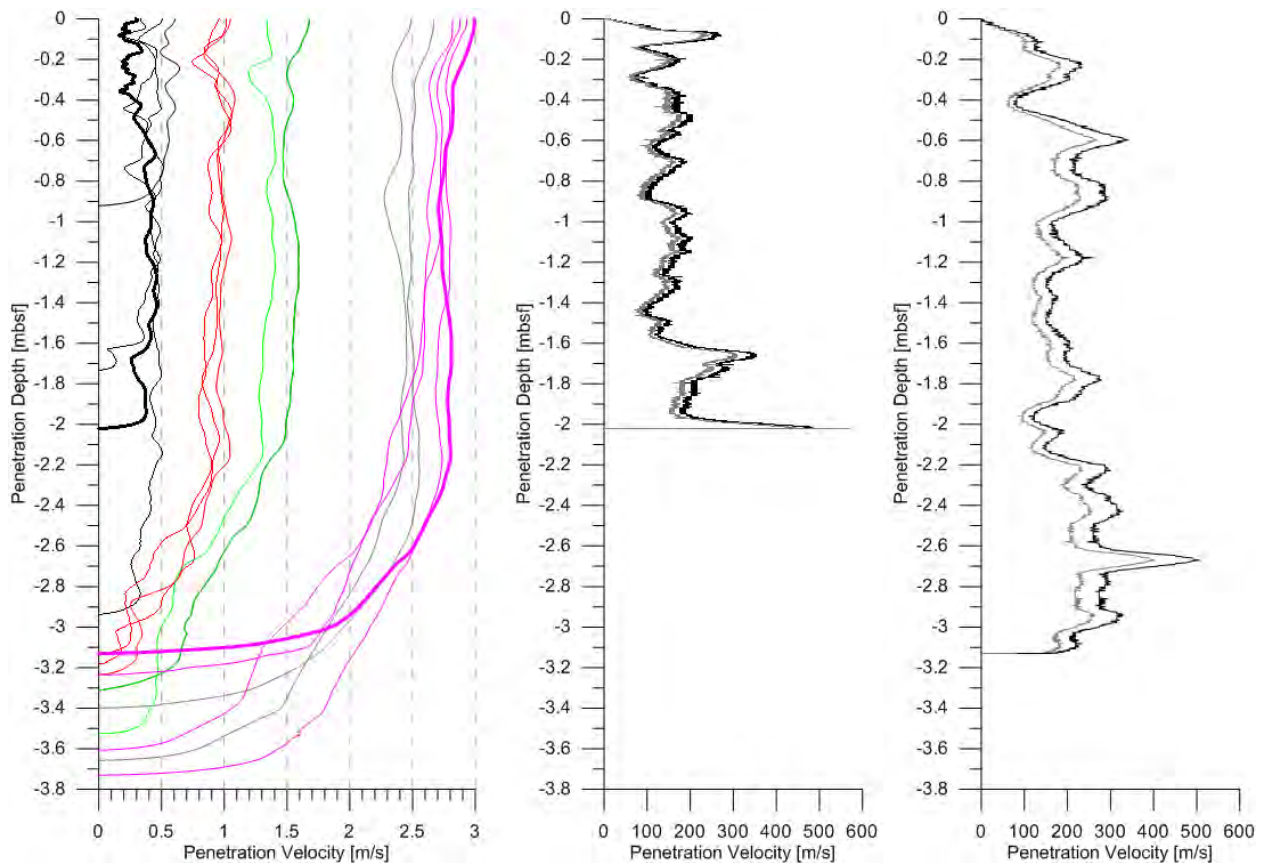
Figure 27 Rate-dependence CPTu testing with the FF-SW-CPTu lance at site TH01. A) Illustrations of the various initial penetration rate (0.5, 1.0, 1.5, 2.5 & 3 m/s), which was used for the 16 dynamic CPTu drops, and the resulting penetration depth. For each “velocity group” the CPTu deployment was carried out four times. This plot contains only successful deployments. B) Difference between rate-corrected and non-rate-corrected values of cone resistance for different initial penetration velocities. Profiles shown here are highlighted in panel A by a heavy line.

Penetration depth ranged from 0.9 mbsf and 3.7 mbsf (Figure 27). The variability of penetration depth increased for the deployments with $v = 0.5$ m/s (black-coloured lines, 0.9 mbsf – 2.9 mbsf) and $v = 3$ m/s (purple-coloured lines, 3.1 mbsf – 3.7 mbsf).

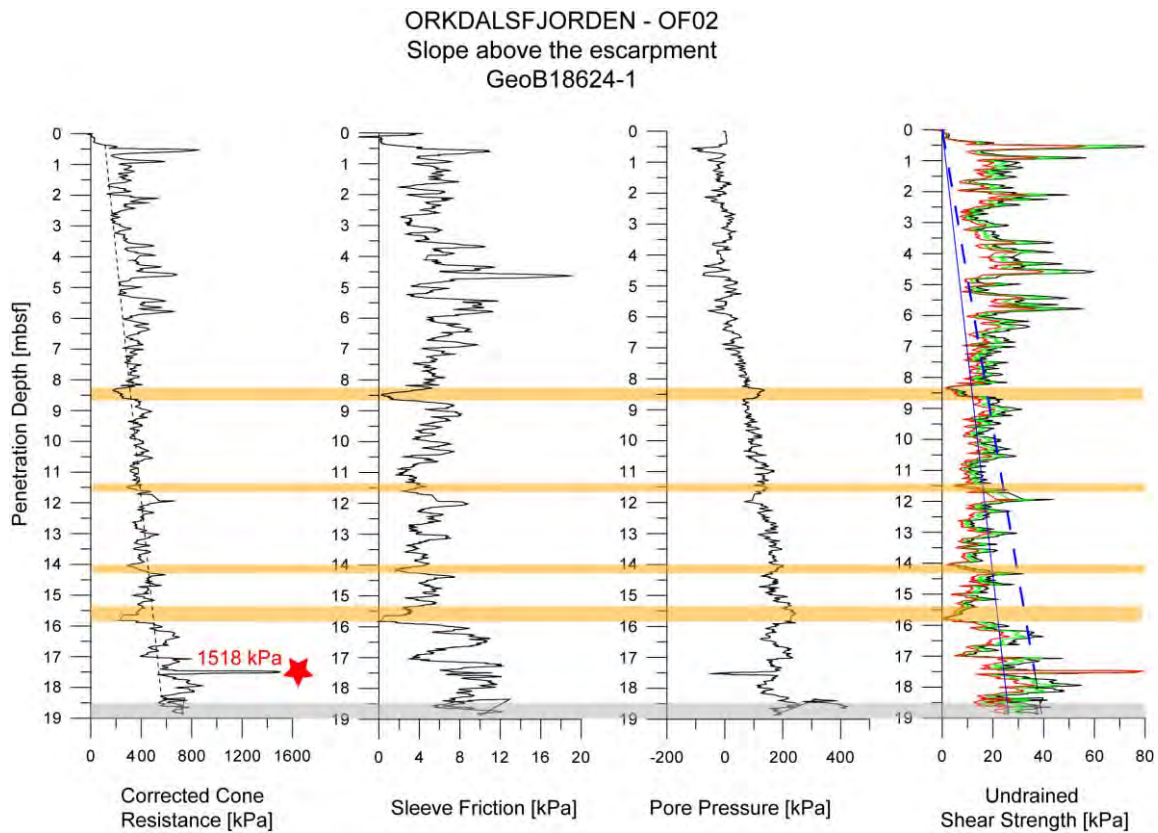
Figure 30 Data plot of the static CPTu profile GeoB18624-1. Red-coloured stars mark data peaks, which have been clipped for better illustration. The number specifies the value of the peak. Blue lines indicate the ratio of undrained shear strength over the depth of the profile (continuous line: s_u ratio = 0.2; dashed line: s_u ratio = 0.3, see Chapter 6.1.1). Orange-coloured bar represents mechanically relative weaker layers defined by decreasing q_t .
