**St3TART**  
FRM for Sentinel-3 Land Altimetry

## Sentinel-3 Topography mission Assessment through Reference Techniques (St3TART)

TD-12 - DESIR FRM Campaign log

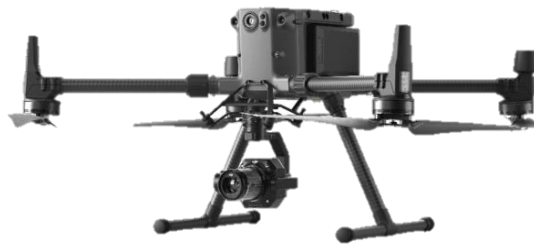
Figure 3.1: Drone M300 equipped with the DJI Zenmuse P1 camera

The material that we brought on board the Commandant Charcot is essentially composed of a DJI M300 drone with 8 batteries with a stabilized pod and a BS60 battery charging station and a set of sensors to evaluate.

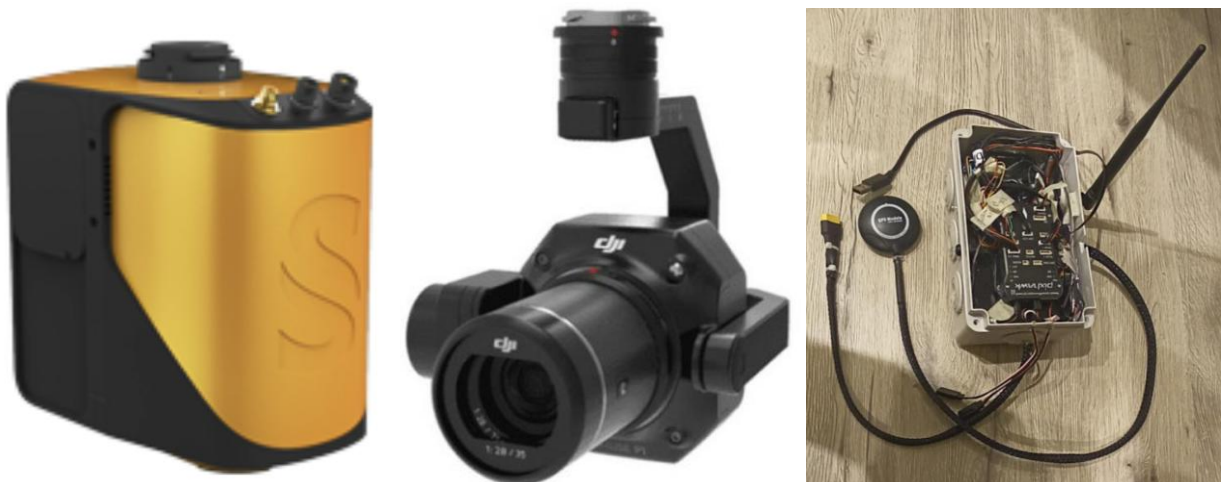
Figure 3.2: the 3 main sensors, from left to right: the 3D lidar YellowScan scanner, the Zenmuse P1 DJI camera and the box including the IMU and 4 altimeters from i-TechDrone.

- 1 YellowScan Mapper+ 3D lidar with camera which was graciously lent to us by YellowScan <https://www.yellowscan-lidar.com/fr/products/mapper-plus/> (estimated cost: 60 000€),
- a high-precision DJI Zenmuse P1 camera lent by i-TechDrone (estimated cost: 800€),
- a box made by i-TechDrone integrating 4 models of drone altimeters:
  - 1 ultrasonic rangefinder I2CXL MaxSonar,
  - 1 laser rangefinder Lightware SF11,
  - 1 radar rangefinder NFA15,
  - 1 TeraRanger EVO40 sonar rangefinder.

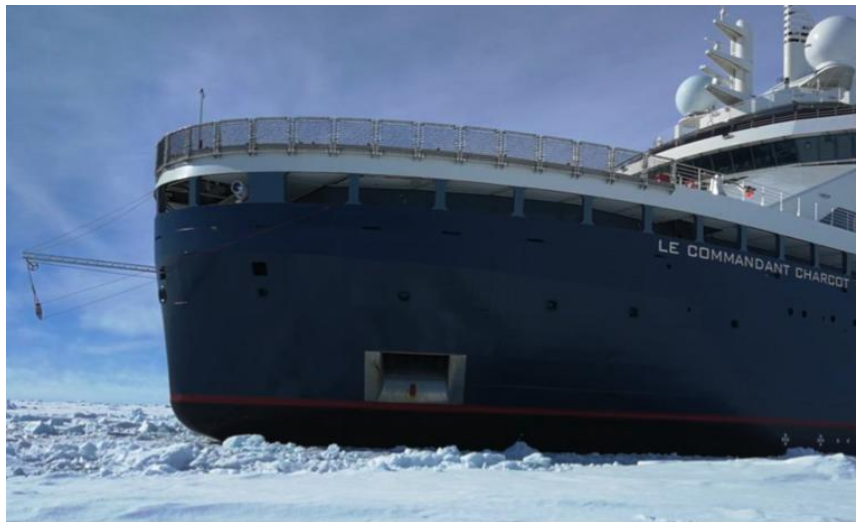
Figure 3.4: Sea Ice Measurement Sensor (SIMS) that is suspended at the front of the boat when it is in the ice pack to measure the thickness of the ice.

It also has many scientific types of equipment, including, for our part, a Sea Ice Measurement Sensor (SIMS) that is permanently suspended at the front of the boat when it is in the ice pack to measure the thickness of the ice. The SIMS, initially designed by Christian Haas (AWI), already equips several icebreakers. It is composed of electromagnetic sensor and a range finder and it provides the ice thickness in real time to the ship's command bridge. These data are also recorded and they will be used to be compared to our drone measurements.

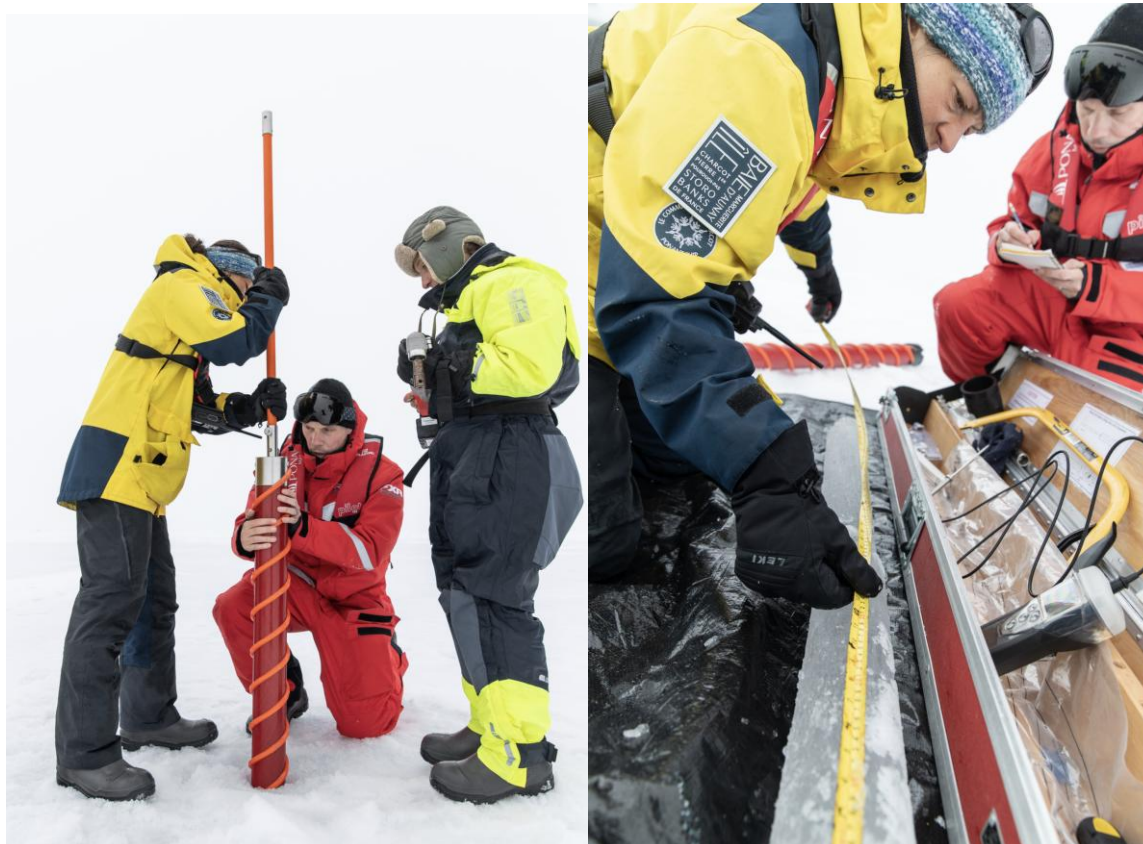
Figure 3.6: Ice coring and measurements of the main characteristics of the ice.

We also had the necessary equipment to make holes in the ice pack and collect ice core. We have thus measured the characteristics of the ice pack at each stopover, and in particular the thickness of ice and snow and the temperature and salinity of the ice (Figure 5).

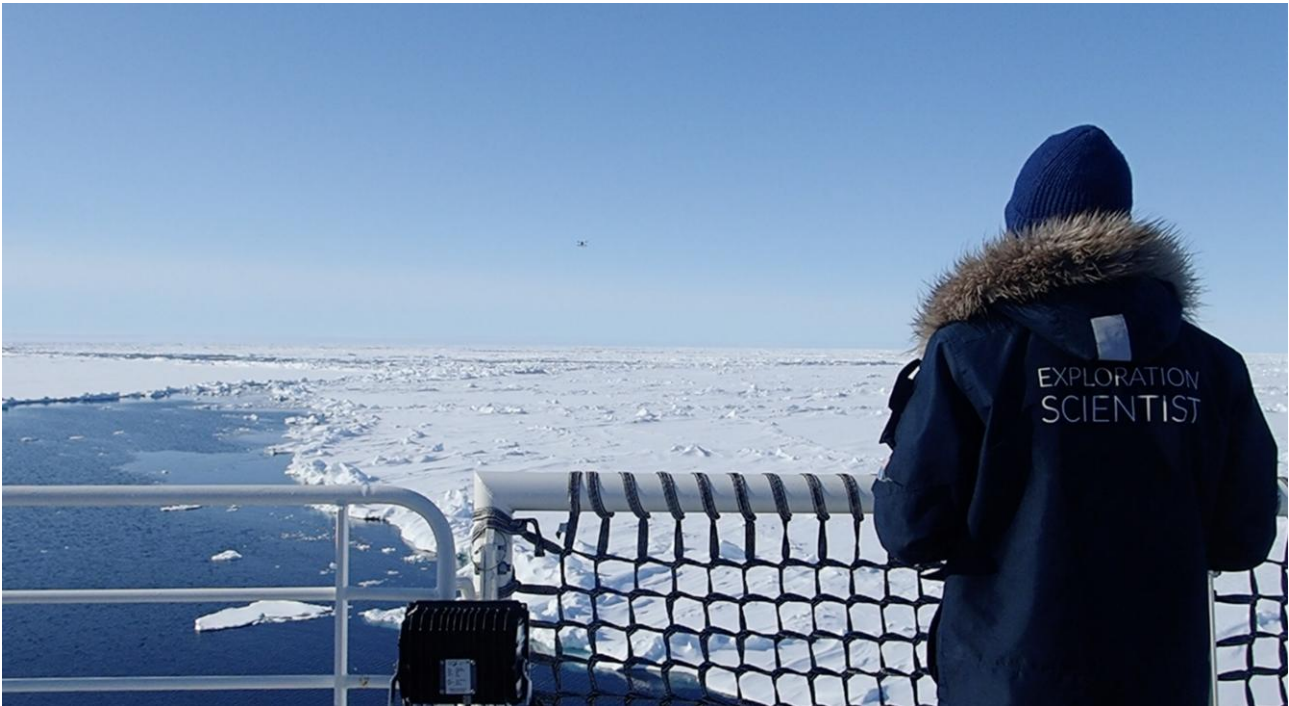
*Figure 4.6: Measurements over sea ice and lead from the bridge*

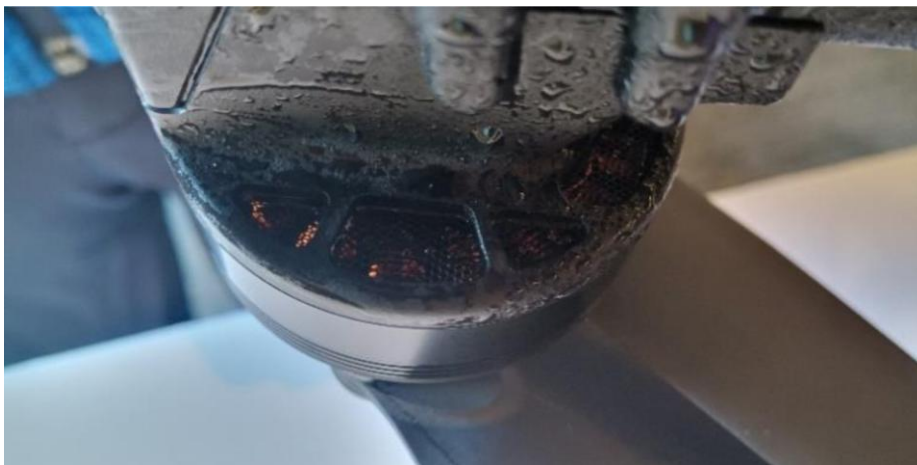
*Figure 4.8: stators covered with melt ice*

- Posed facing the wind.
- Instantaneous stop of the two rear engines as soon as the shutdown is requested. After examination, the stators are covered with melt ice (see Picture below).

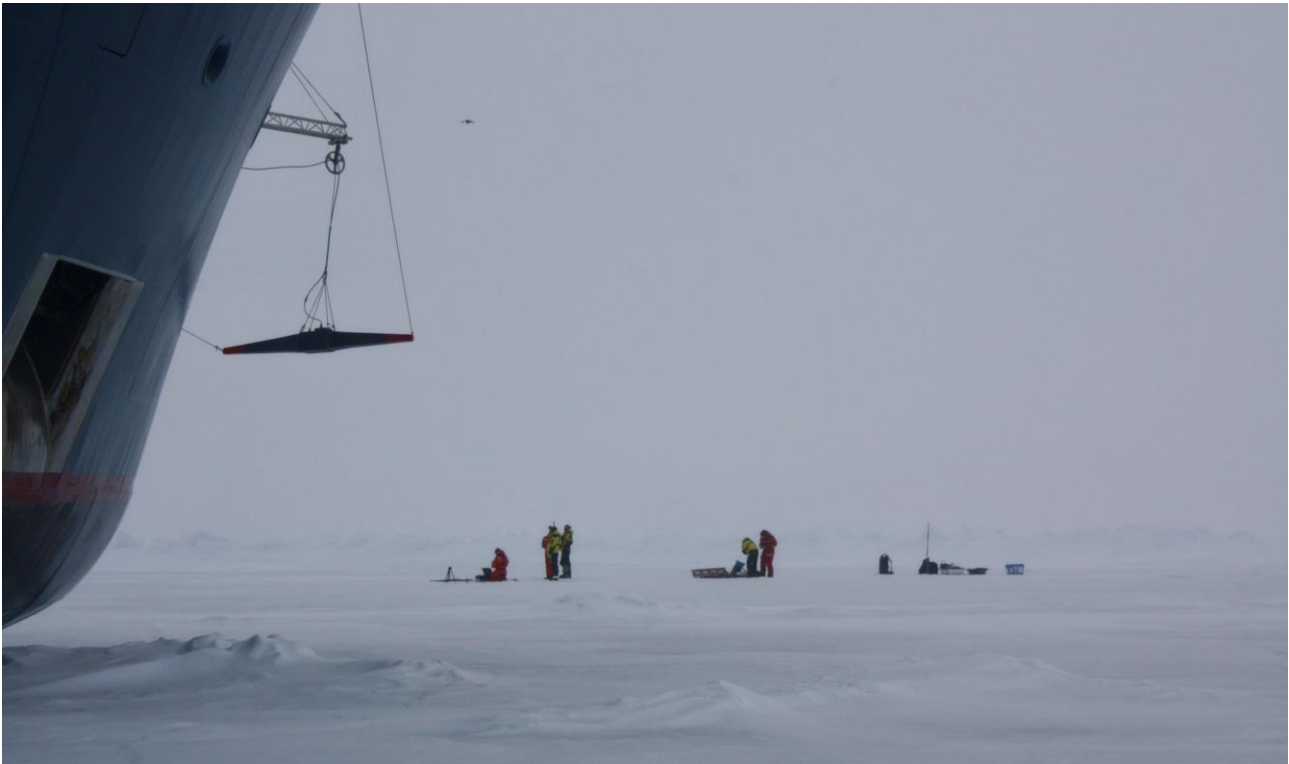
Figure 4.9: July 16<sup>th</sup> Measurements of sea ice characteristics using different sensors, including drone, SIMS and drills.

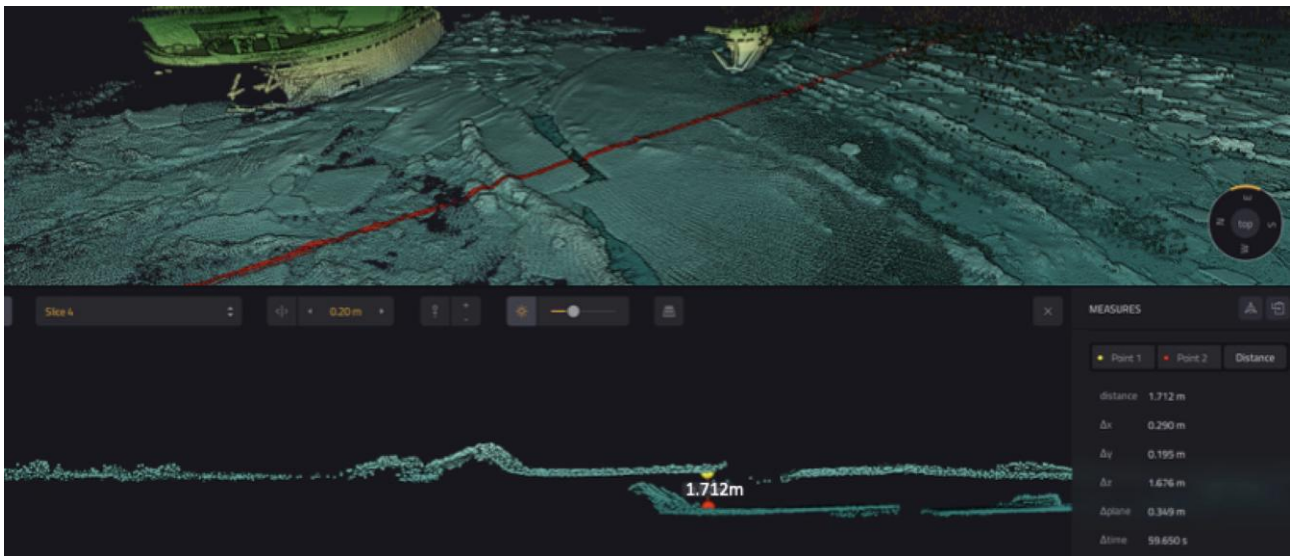
*Figure 5.4: the bottom image corresponds to the red cut of the top image. We can observe an important height difference of 1.71m between two measurements of the same floe. This difference is due to the insufficient precision of the altitude of the drone. This problem could probably be solved using the PPP-AR GNSS post-processing.*

The usual technic to improve GPS positioning consists in using a static reference GNSS station to apply the well-known differential-GPS approach. But such an approach is not applicable over a drifting ship among a drifting ice. However, it exists GNSS post-processing technics such as the PPP-AR solution that allows improving the positioning down to few centimetres. We discuss about this possible improvement in Section 6.2.

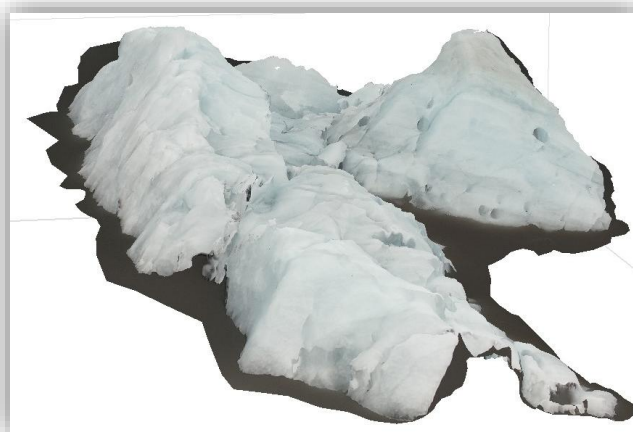
Figure 5.6: Photo of a 23m long growler on the left and its model obtained by photogrammetry on the right.

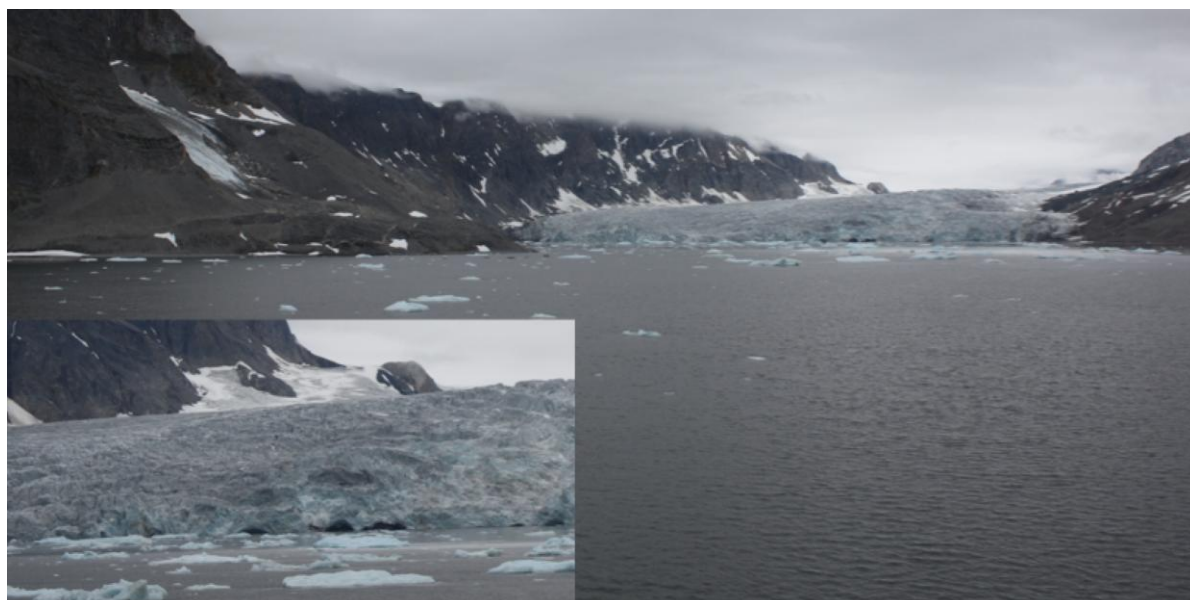
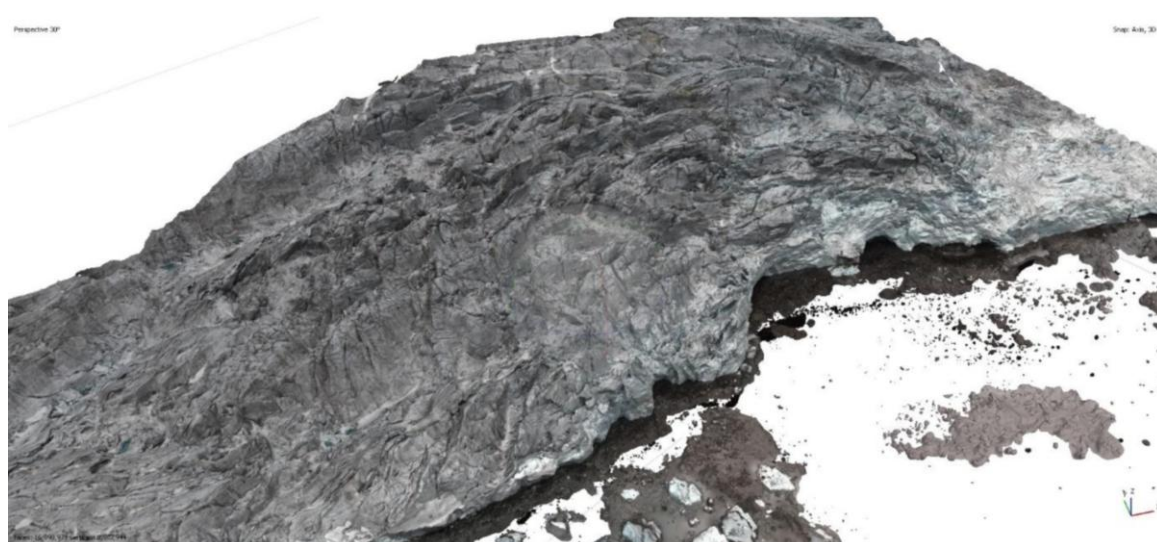
Figure 5.7: At the top, an overall photo of the glacier front, with a zoom on caves, and at the bottom, the 3D model produced by photogrammetry from the images acquired by the P1 camera.

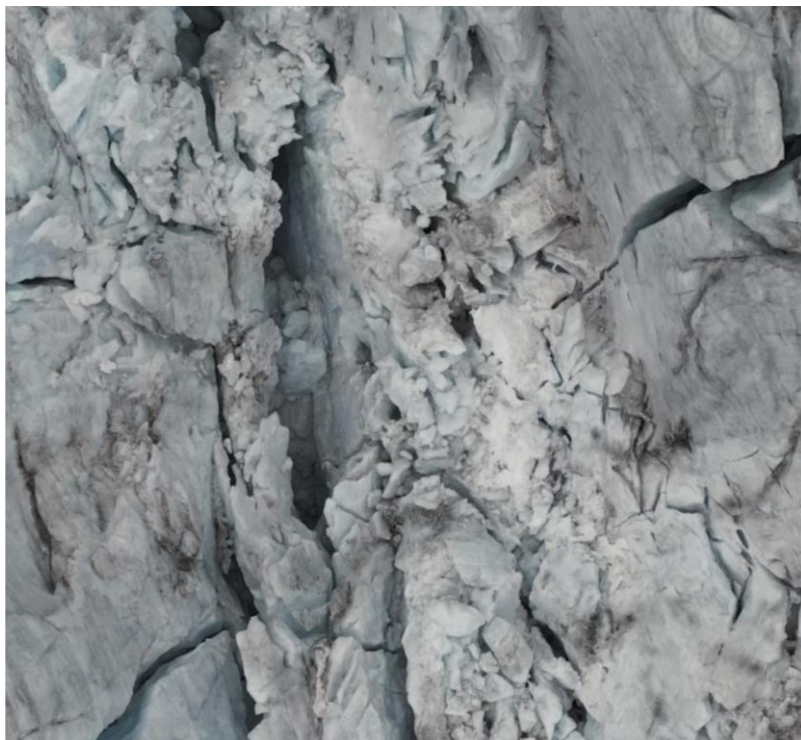
*Figure 5.8: some zooms within the 3D model. We can observe fractures, snow plates and melt pools.*

The resolutions obtained are impressive with very precise representations of fractures, snow plates and melt pools.
